LABORATORY TEST REPORT: EL 2005-06-005 Rev. 1

SUBJECT: GIG-Array® Lead Free Qualification Testing–Vibration, Shock, 3 Point Bend, Temp Cycling

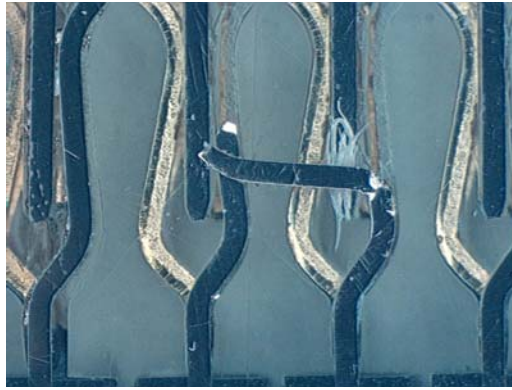
FIG. 1 – BENT SIGNAL TINE, SPL. 2-14, ROW S

All samples of the 200 position, 28mm samples (group 1) successfully completed 2670 temperature cycles with no events. Two samples of the 296 position, 35mm samples (group 2) exhibited electrical failure. Sample 2-4 exhibited electrical failure in the ground circuit at cycle #1070. Sample 2-14 exhibited electrical failure in the signal circuit at cycle #283.

Metallographic x-sections of samples 2-4 and 2-14 were prepared to determine if solder joint cracking caused the electrical failures. Each row of the daisy chain circuit exhibiting electrical failure of each sample was examined. Solder joint cracking was not observed in any of the failed samples. Root cause of the electrical failure could not be established from the x-sections. The only anomaly observed was a bent contact of one of the 2 tines comprising a signal contact in row S of sample 2-14. Figure 1 illustrates the observed bent contact.
