LABORATORY TEST REPORT: EL 2005-06-005 Rev. 1

SUBJECT: GIG-Array® Lead Free Qualification Testing–Vibration, Shock, 3 Point Bend, Temp Cycling

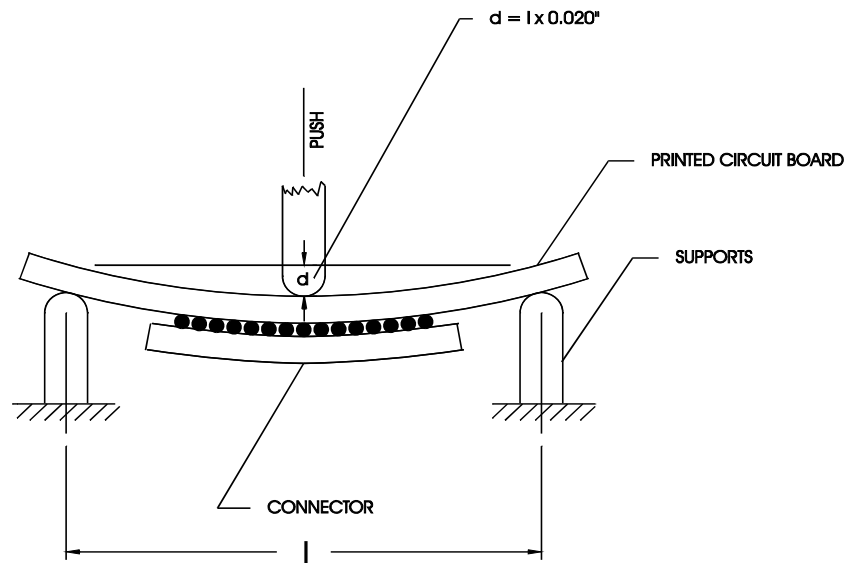
FIG. 2 - 3 POINT BEND SET-UP

Three contacts of 200 position plug sample #1 exhibited marking dye in the solder ball-to-PCB interface. Position D13 exhibited 50% dye, D17 exhibited 10% dye, and F13 exhibited 80% dye. None of the other samples exhibited any cracking. The predominant failure mode observed when removing the connector from the PCB was PCB pad separation.
